ERWAN ROUSSEL (\*) & MARIE-FRANÇOISE ANDRÉ (\*\*)

## QUANTITATIVE ASSESSMENT OF PRE- AND POST-RESTORATION WEATHERING RATES OF LIMESTONE MAYAN TEMPLES (UXMAL, YUCATAN)

**ABSTRACT:** ROUSSEL E. & ANDRÉ M.-F., *Quantitative assessment of pre- and post-restoration weathering rates of limestone Mayan temples (Uxmal, Yucatán)*. (IT ISSN 0391-9838, 2013).

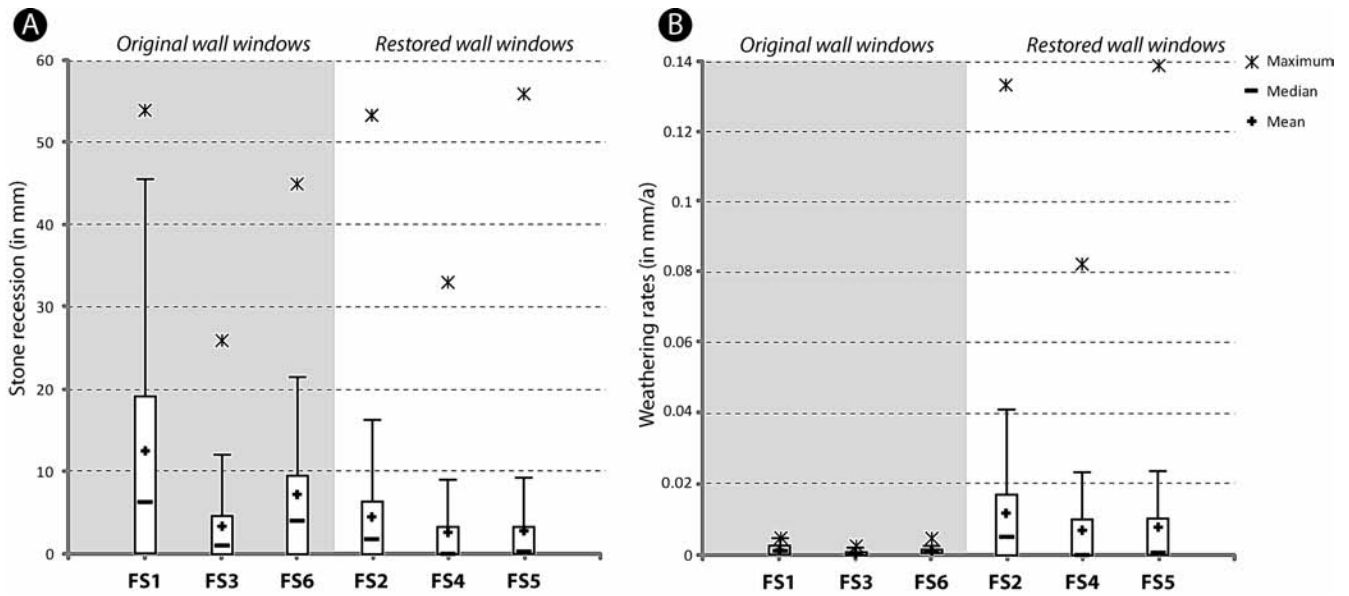
FIG. 6 - Box plots of stone recession measurements (A) and computed weathering rates (B) of the six fine-scale photogrammetric windows of the south façade of the House of Turtles.

The comparison of the weathering rates of the original and restored parts of the façade was also performed based on the analysis of fine-scale windows. Summary statistics of stone recession values and weathering rates for each window are presented in tab. 3 and fig. 6. This fine-scale analysis shows similar results to the façade scale diagnosis: raw stone recession measurements of the original and restored parts of the façade have a similar distribution (fig. 6A), whereas the calculated weathering rates show highly significant differences between the restored and original parts (fig. 6B). The average weathering rates of the restored section of the façade are 5 to 37 times faster than the ones of the original section (respectively at 0.065 compared to 0.013 mm/a, and 0.113 compared to 0.003 mm/a).

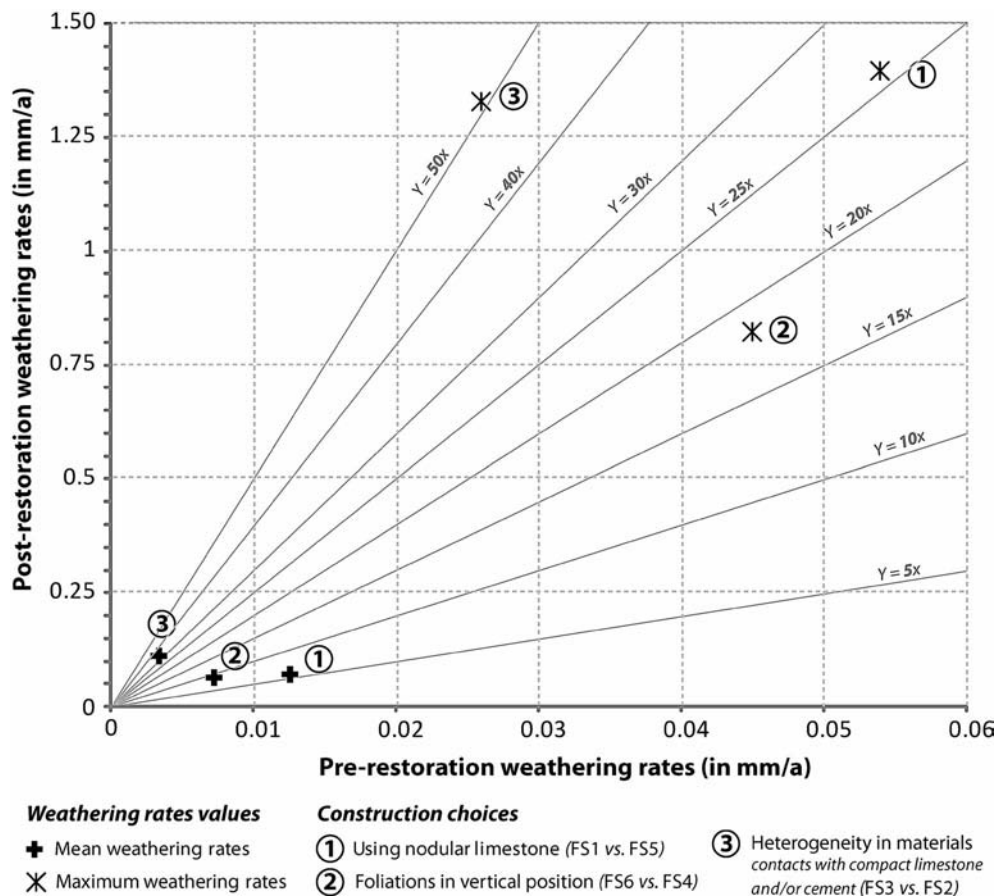
FIG. 8 - Comparison of pre- and post-restoration weathering rates according to the type of construction choice.

The sampling of fine-scale photogrammetric windows based on similar construction choices on both original and restored sections of the south façade allows to strictly compare pre- and post-restoration weathering rates (fig. 8). Regardless of construction choices, the mean pre-restoration weathering rates are between 5 and 40 times lower than the post-restoration rates. Similarly, the maximum pre-restoration weathering rates recorded are 18 to 50 times lower than the post-restoration rates. We can conclude that whatever the construction type, the post-restoration weathering rates are systematically higher than the pre-restoration weathering rates.

However, the amount of contemporary increase of stone deterioration varies according to the construction choices. Whereas average post-restoration weathering rates are 5 to 10 times faster than pre-restoration rates for both nodular and vertical limestone ashlar, they are almost 38 times faster for heterogenised materials. Similarly, the maximum rates are 18 to 26 times faster for nodular and vertical blocks, compared to 51 times faster for heterogenised materials.

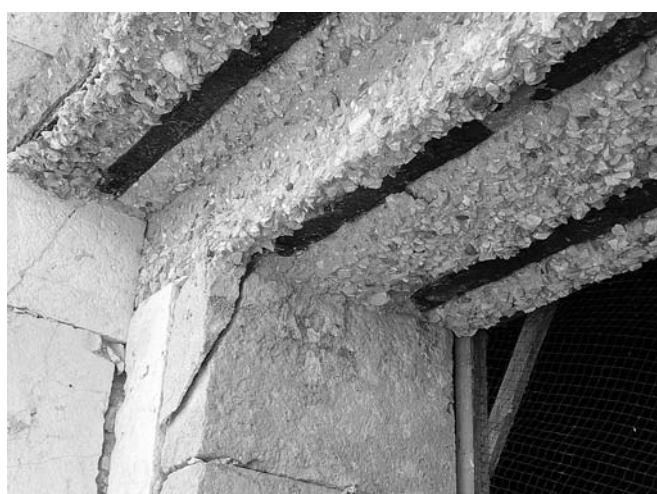
FIG. 10 - Limestone cracking provoked by the replacement of a wood lintel by a reinforced concrete lintel in the Governor's Palace, next to the House of Turtles (Uxmal).

The second main finding deals with the acceleration of limestone deterioration due to the replacement of wooden lintels by cement lintels above the façade doors. Hotspots of limestone deterioration that appear on the façade (in black in fig. 4, see above) are systematically located below these cement lintels incorporated in the ashlar masonry in the early 1970s. The deleterious effects of cement are confirmed by the very fast post-restoration weathering rates recorded in ashlar blocks located next to the cement (window FS2): these rates are on average 38 times faster than the corresponding pre-restoration weathering rates (window FS3). In the governor's palace next to the House of Turtles, additional damage including limestone cracking is induced by iron fixings incorporated in reinforced concrete lintels (fig. 10). Such effects have been widely observed in other sites worldwide, such as the Acropolis in Athens where iron fixings have been removed and replaced with titanium substitutes (Ashurst, 2007).
