ORNELLA TURITTO (*), MARCO BALDO (*), CHIARA AUDISIO (*) & GIORGIO LOLLINO (*)

A LiDAR APPLICATION TO ASSESS LONG-TERM BED-LEVEL CHANGES IN A COBBLE-BED RIVER: THE CASE OF THE ORCO RIVER (NORTH-WESTERN ITALY)

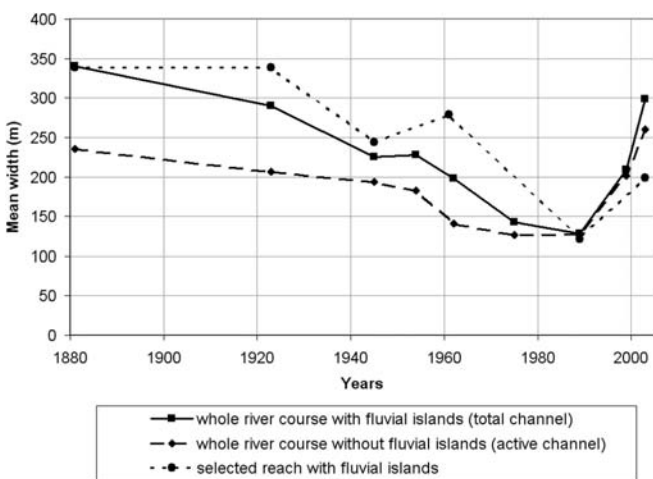
FIG. 2 - Temporal trends of the mean width of the «total channel» (with islands, continuous line) and the «active channel» (without islands, broken line) of the 25 km Orco River reach over the 1881-2003 period. The diagram also shows the trend of the mean width of the total channel coming from the six cross-sections of the selected reach (dotted line, see the last line in table 3).

It has to be pointed out that the 2000 flood has been the maximum recorded since 1920 (fig. 4). The ARPAP (2003, p. 55) assigned it a return period of 80 years. During this flood severe bank erosion processes took place and channel avulsions dissected the older or new islands from the floodplain, inducing a widening of the total channel (see the 1975 and 2003 channel configurations in fig. 3). On the whole 25 km long reach the channel widening reached +133% on average compared with the 1989 width (fig. 2).

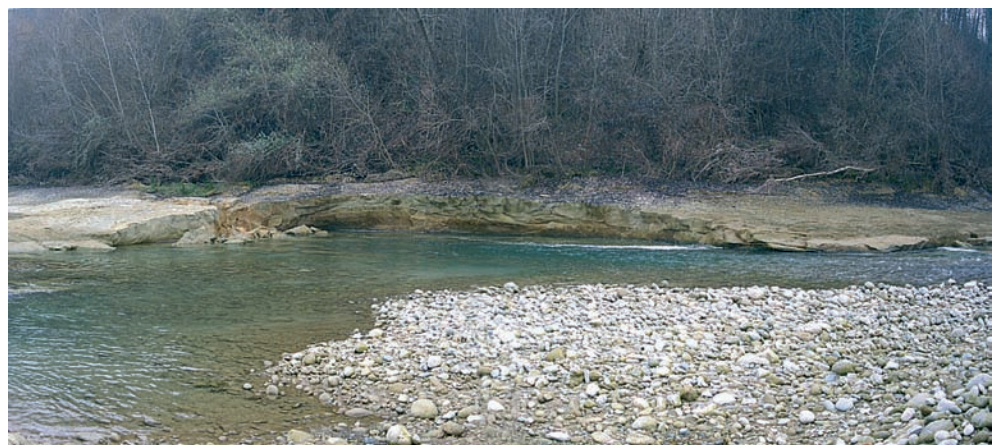
FIG. 6 - The Orco River 1.5 km upstream of the Feletto bridge in January 2007 (downstream to the left). Since the beginning of the 1980s the vertical erosion has incised the lacustrine deposits previously buried by fluvial deposits.

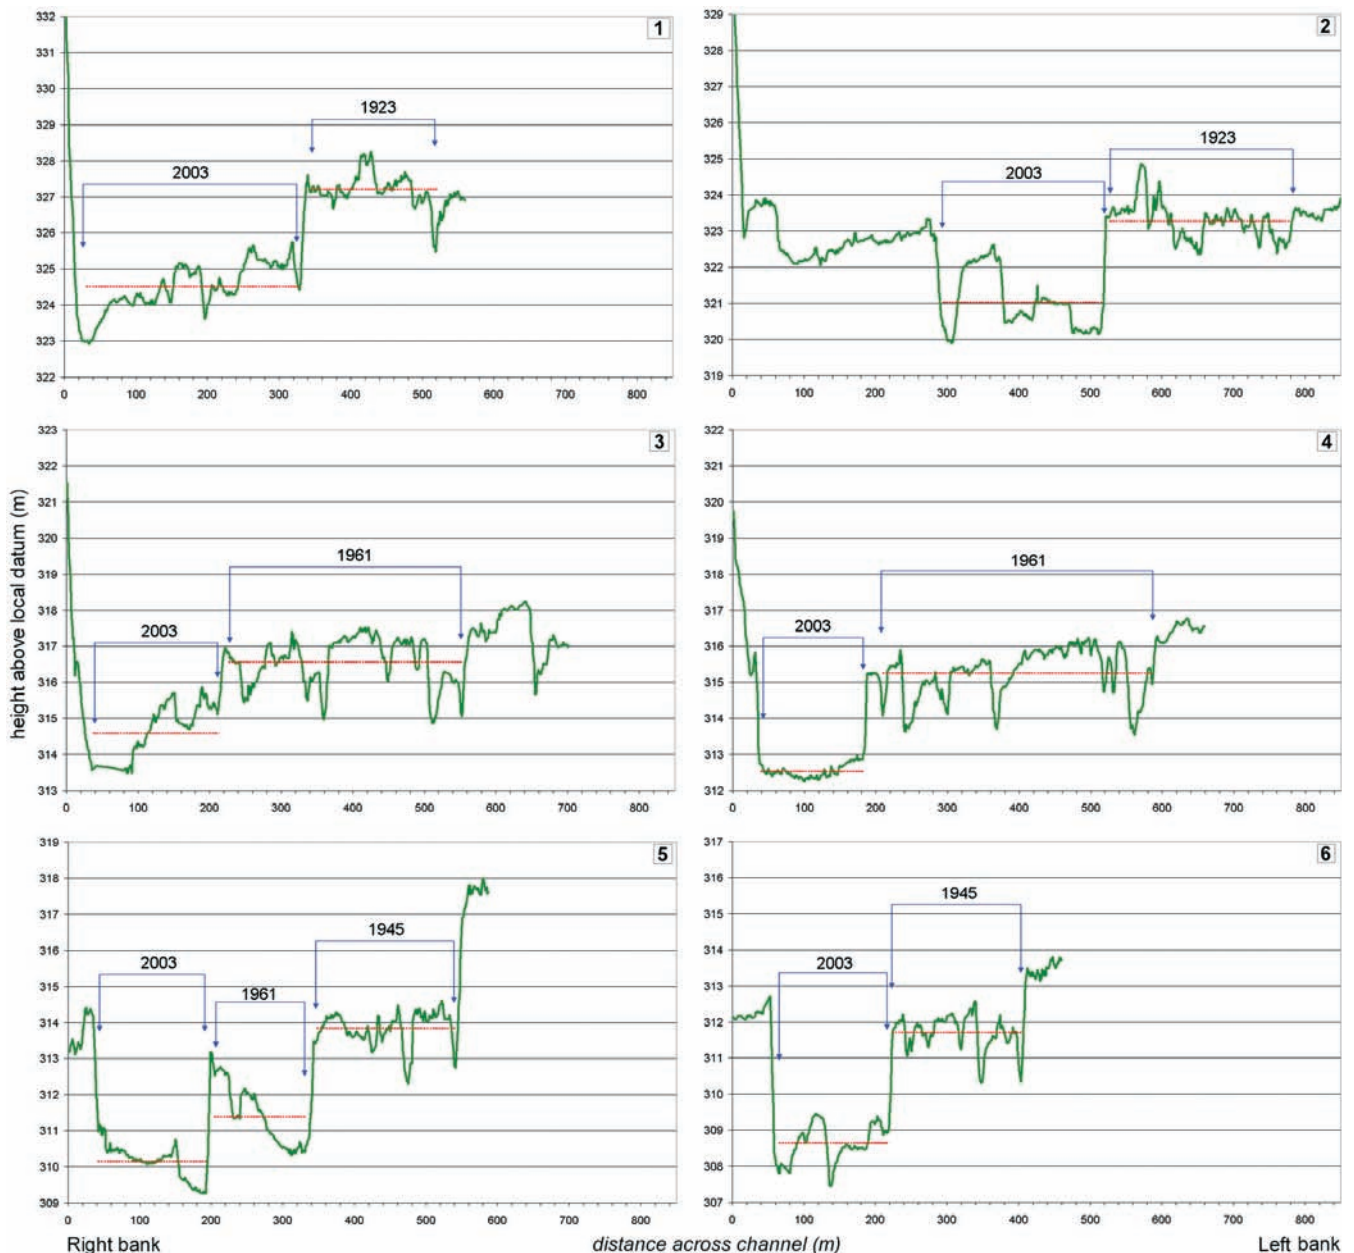
FIG. 8 - The six cross-sections, drawn out from the 2003-DTM, are numbered 1 to 6 from upstream to downstream. The positions of the present channel (2003) and of the remaining portions of the older ones (occupied until 1923, 1945 and 1961) are given. The red lines show the mean level of the river bed in different years.

On each cross-section the limits of the present and the older river beds are identified by merging the photographic interpretation and DTM data (fig. 8). Afterwards the mean level of every river bed, the present one (2003) and the old ones (1923, 1945 and 1961), was extracted from the processed data of the six cross-sections (see red lines in fig. 8). This operation allowed to average the more stressed unevenness of every river bed.

And then, thanks to the altimetric data provided by the cross-sections (fig. 8), the difference from the old to the present mean levels of the river bed was measured. In table 3 these altimetric data were associated with the channel widths and their percentages of change (increases/decreases) at various dates.

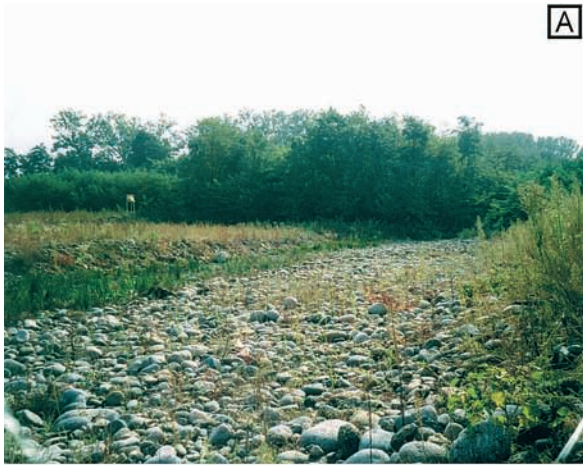
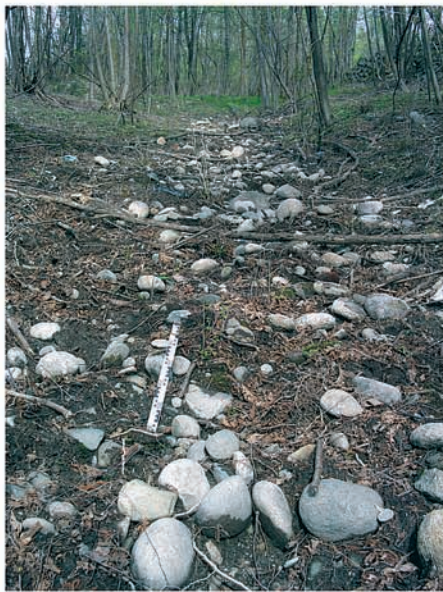
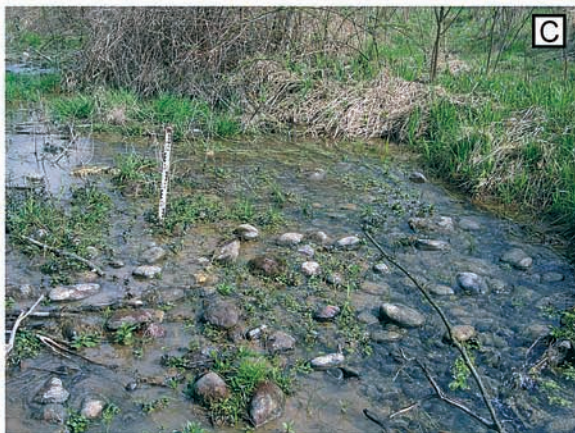
FIG. 9 -The present appearance of the abandoned channels: A) the channel occupied until 1961 and intercepted by cross-section 4 (photograph taken in September 2007); B) the one occupied up to 1945 and intercepted by cross-section 6 (photograph taken in April 2009); C) the one occupied up to 1923 and intercepted by cross-section 2 (photograph taken in April 2009, after heavy rainfall).

It has to be pointed out that no significant depth of sediments filled the abandoned channels at the crossed sites. Sediments and colluvial deposits just filled the gaps among the cobbles (fig. 9a and 9b). Moreover, in some cases old channels can still be occupied by flowing water during heavy rainfall (fig. 9c).
