GUIDO NIGRELLI (\*) & CHIARA AUDISIO (\*)

## THE MAY 2008 EXTREME RAIN EVENT IN THE GERMANASCA VALLEY (ITALIAN WESTERN ALPS): PROCESSES AND EFFECTS OBSERVED ALONG THE HYDROGRAPHIC NETWORK AND VALLEY SLOPES

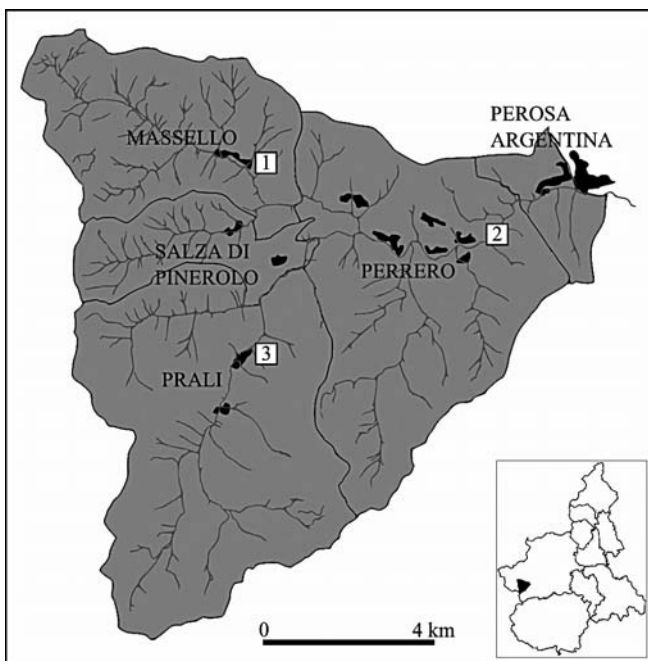
FIG. 1 - The Germanasca river basin: municipal names and borders (black color lines), built-up areas (black color), main river channel (grey color) and location of the three AWS: 1. Masseo (elevation 1388 m a.s.l.; UTM-WGS84 4980319N, 347375E); 2. Perrero (662 m a.s.l.; water-gauge zero 649.190 m a.s.l.; 4978654N, 355064E); 3. Prali (1385 m a.s.l.; 4974207N, 346645E).

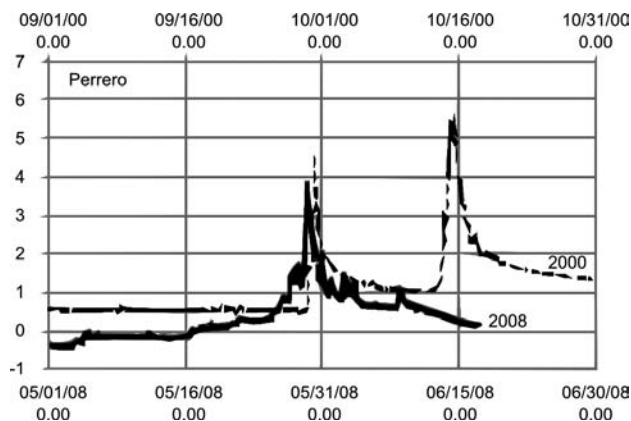
FIG. 3 - Water level (m) of the May 2008 event (lower axis) and the October 2000 event (upper axis) at the Perrero station (dati ARPA Piemonte, 2008c).

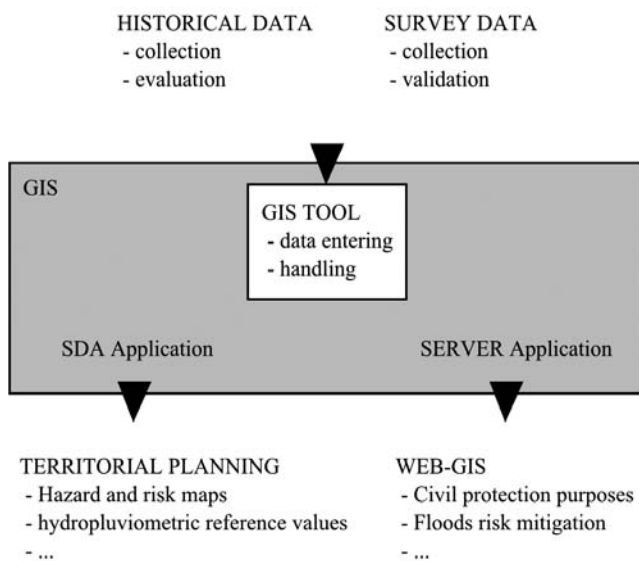
FIG. 5 - Flow chart of the «Sistema Informativo Territoriale Rischio Idraulico e Geologico» (SIT-RIG).

A detailed analysis of the main interactions between a rainfall event, the natural phenomena it causes and the resulting damage was conducted using a methodology developed by the CNR-IRPI, Torino. The methodology uses a GIS application decision-making support named «Sistema Informativo Territoriale Rischio Idraulico e Geologico (SIT-RIG)». The SIT-RIG works extremely well for supporting decision-making processes in geo-hydrologic risk mitigation in relation to civil protection and local and basin-wide land-use planning. With this GIS application, vast amounts of georeferenced data can be managed quickly and accurately to generate new information. Fig. 5

illustrates a flow chart of the method procedure. The SIT-RIG uses ESRI ArcView GIS software within which an extension was developed to facilitate the entry of data collected from historical and contemporary documentation sources. The applied methodology has already been illustrated in Audisio & *alii* (2009). Multilevel data processing generates spatiotemporal correlations between a point theme called «event-phenomenon-damage» and various basin landscape features that highlight high-risk and hazardous areas.

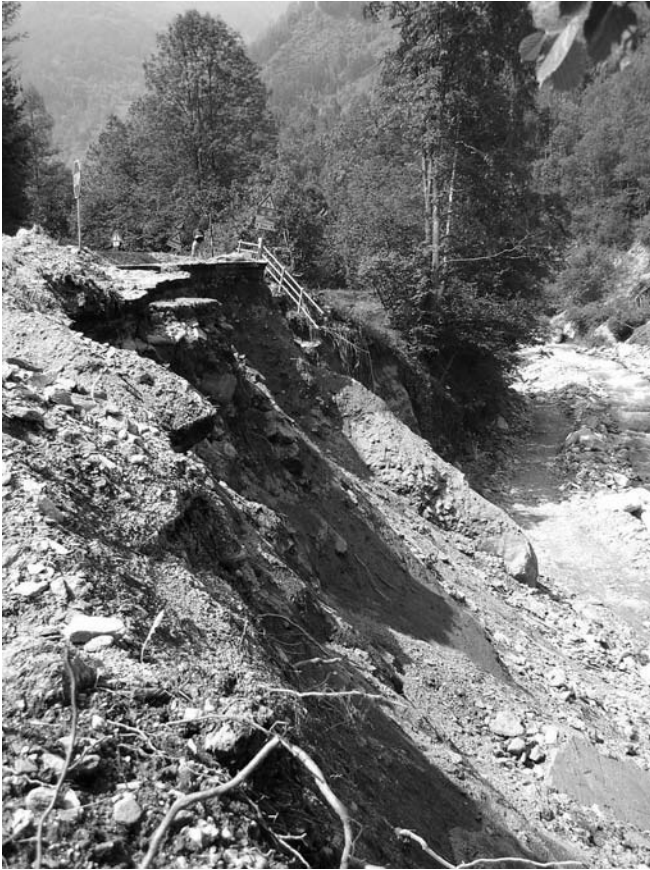
FIG. 6 - Intense bank erosion involving the provincial road near the junction of the road leading to Salza di Pinerolo and Massello.

Analysis revealed a number of phenomena along the stream trunk, its tributaries and on basin slopes. Along the main stream network, effects of bank erosion and flooding were assessed. Specifically, in the Germanasca of Prali branch, between Borgata Ribba and Ghigo di Prali, erosion of the right and left banks was noted. Bank erosion partially damaged road infrastructures and defense works, some of which had been built after October 2000 event. Near the Molino Bridge, just downstream from Borgata Ribba, intense flooding reactivated an abandoned channel on the left side of the main stream. The bridge itself remained undamaged, but the road crossing was blocked and damaged. At Prali widespread bank erosion was noted, together with major flooding effects in the stream bed. Upstream from Prali Villa, on the left stream bank, erosion damaged bank defense works and swept away part of the provincial road. In the Germanasca of Massello branch, extensive right bank erosion seriously damaged the road junction where secondary roads lead to the towns of Massello and Salza di Pinerolo. Here, part of the slope between the stream and the road bed failed, forming a scarp approximately 20 m high. Near the bend in the road to Salza di Pinerolo, the road bed was washed away (fig. 6). Transport of floating material (tree trunks and branches) was greater in this reach of the stream than in the other rivers of catchment. Near Perrero, bank erosion and flooding were noted, with deposition of sediment. In this seg-

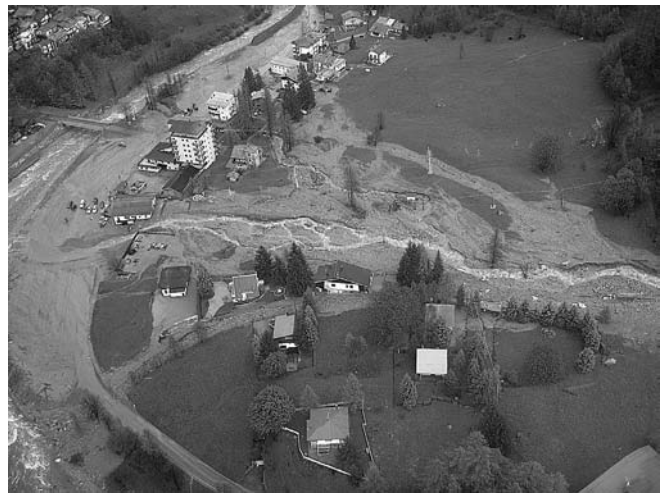
FIG. 7 - Stream transport on the alluvial fan of the Rio Iclo (Photo courtesy of G. Lollino).

Mass solid transport in the Rio Iclo near the chair lift station at Prali (Ghigo) was one of the largest in terms of

area involved and of damage to man-made works on the alluvial fan (fig. 7). Mass solid transport also reactivated an old stream bed on the left side of the fan which had been filled in to build an access road to several houses. Near the fan apex, the material overtopped the natural banks of the stream, damaging the right side of a weir and depositing some of the material transported (fig. 8). The material carried to the valley floor measured from approximately a centimeter to several centimeters in size and was contained in a clay-sand-gravel matrix. The small granulometric size of the transported sediment is given by the basin lithology, which consists of micashist layers. In this process, the major damage occurred to the chairlift station and service buildings on the alluvial fan. The houses on the left side of

the fan sustained external damage when they were hit by debris and uprooted trees carried by the old stream bed.

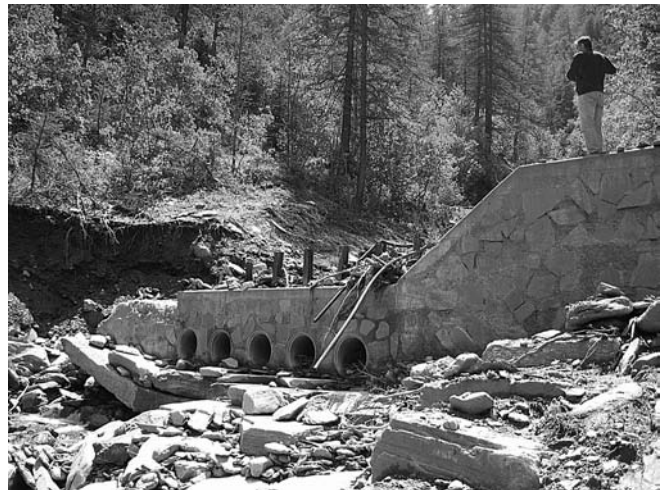
FIG. 8 - Apex of the alluvial fan of the Rio Iclo. Deep erosion; the right shoulder of the weir has been completely washed away. Just downstream from the weir, to the left, note the differences in rock size: scattered large rock masses and a fine matrix composed of sand and gravel.

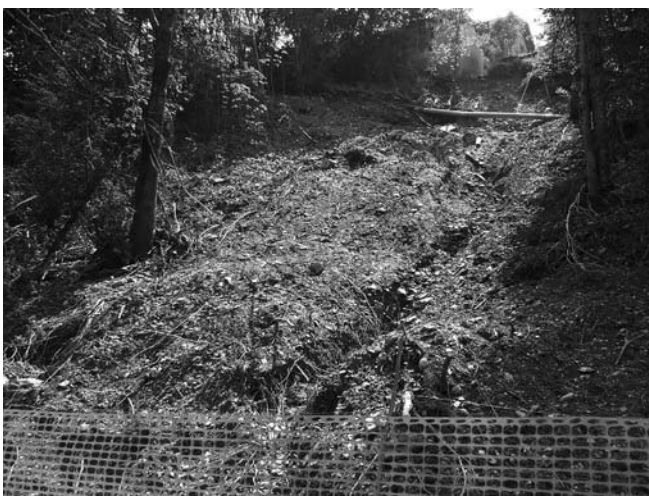
FIG. 9 - Rotational landslide near Campo la Salza. Note the sewer pipe exposed by the landslide.

Nearly all slope failure processes were classifiable as landslides involving soil cover, of which 60% were classified as soil slips and the remaining 40% as rotational slides. The majority of soil slips occurred on the left slope of Prali valley; the rotational slides occurred in all three branches of the basin. A 300 m stretch of the road running below the houses at Campo la Salza was blocked at four points; detachment niches were observed at two points along the slip surface of the slope on which some houses are located (fig. 9). The processes involved a vast portion of the slope, blocking the road and damaging the sewer system. One landslide also interacted with the hydrographic network.

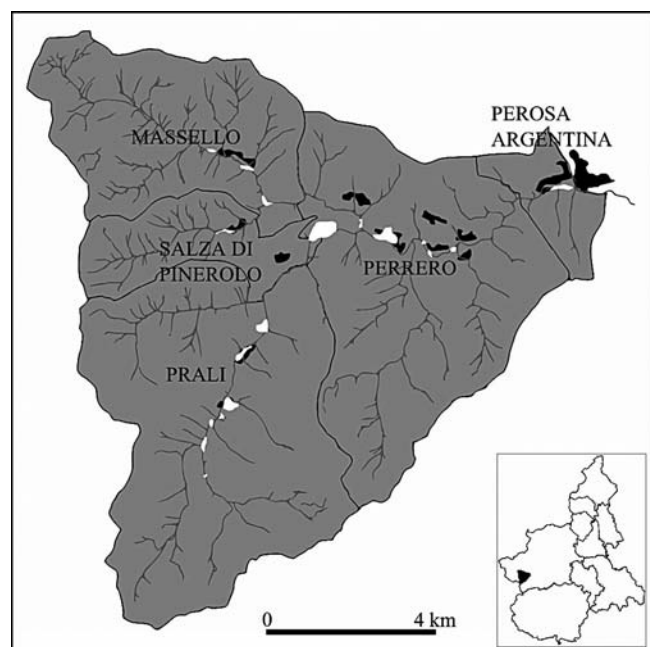
FIG. 10 - The Germanasca river basin: municipal names and borders (black color lines), built-up areas (black color), main river channel (grey color) with hazard and risk areas (white).

Based on calculations using the SIT-RIG tool, area sectors were accurately defined which, because of the higher frequency of phenomena and damage, may be considered as being at higher risk (fig. 10). High-risk sectors may be classified into two different types: areal and linear. The high-risk areal sectors are those most subject to the effects of slope dynamics (e.g., rock falls and complex falls), as in the case of the accumulation talus on which the town of Perrero is built. In the upper valley at Ghigo di Prali, reactivation of alluvial fans by debris flows or massive solid transport is

more prevalent. Events occurring in this area have been recorded since 1921. Activated several times in the past, the only critical point related to slope dynamics is near Campo la Salza, along the slope portion between the buildings and the provincial road. The area sectors more vulnerable to linear risk are affected by phenomena related to fluvial dynamics such as bank erosion: the most frequent sites were observed at the Molino Bridge (Borgata Ribba, upstream from Ghigo di Prali), Borgata Giordano (just upstream from Ghigo di Prali), Prali Villa (upstream and downstream), Campo la Salza, at the confluence of the Germanasca of Prali and Germanasca of Massello streams, downvalley at the bridges at the hamlets of Trossieri and Chiotti Superiore, and at Pomaretto on the right bank of the stream.
