GIUSEPPE MANDRONE (*), LORENZO BURATTI (**), ALESSANDRO CHELLI (**),
LUIGI LOPARDO (***) & CLAUDIO TELLINI (**)

A LARGE, SLOW-MOVING EARTH FLOW IN THE NORTHERN APENNINES: THE SIGNATICO LANDSLIDE (ITALY)

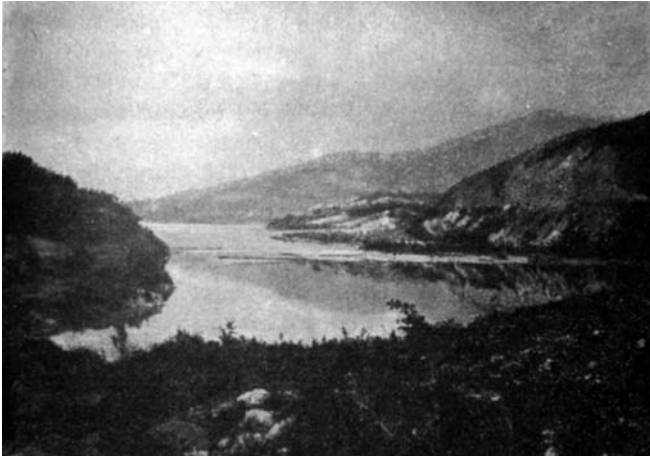
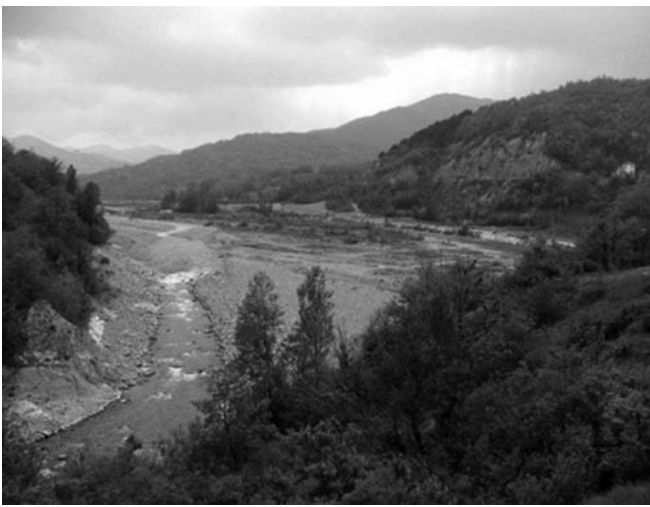
FIG. 7 - An old picture of 1906 (top) and a recent photo (bottom) showing the river bed and the zone of accumulation of the landslide that in the past created the lake.

When a consisting quantity of this clayey and loose material is available, rainfall can act, inducing slides and flows, which can even reach the river bed, sometimes creating a temporary dam and the consequent lake (fig. 7). The first results from the inclinometer at Signatico seem to highlight that a big portion of slope is still moving, while the flanks seem stable.
