MARIA THERESA FARRUGIA (*)

COASTAL EROSION ALONG NORTHERN MALTA: GEOMORPHOLOGICAL PROCESSES AND RISKS

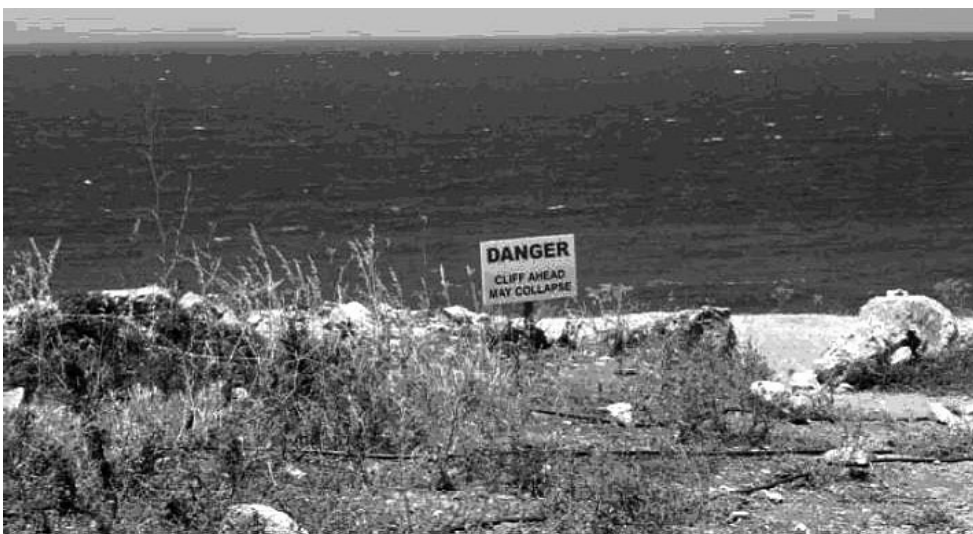
FIG. 4 - Sign indicating possible landslide activity at Ghajn Tuffieha headland.

Yet, at Ghajn Tuffieha Bay, coastal erosion hazard management is not present. In fact, the protection given to this area aims mostly towards safeguarding the present natural habitats situated on the Blue Clay slopes. Nonetheless, the buildings present at this bay are protected by membrane layers and also considerations are being taken towards relocating a dilapidated building further inland from its location. Truly this building was abandoned during the last century because it faced serious threats from landslide activity. Considerations are currently being taken regarding this latter activity, but these mainly focus at indicating people that these areas have landsliding possibilities, as seen in Figure 4.

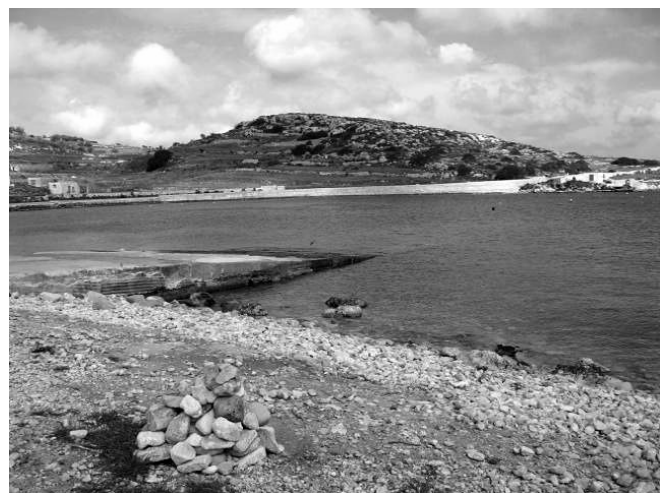
FIG. 6 - Coastal structures at Mistra Bay.

With regard to coastal hazard management at Mistra Bay, one can only observe two coastal structures which are a rock wall and a slipway, seen in Figure 6. However one should note that the slipway was not built for such purposes but for the use by boats. The slipway has in fact in the short run led to coastal deposition however when analysing the coastal configuration for the last century it became evident that in the long run such structure has led to the erosion of the sandy beach on the left side of the bay. Moreover the construction of the rock wall although it had declined wave impact, it has hindered sediment accumulation in such part of the bay leading to more coastal erosion.
