GIOVANNI TOSATTI (*)

SLOPE INSTABILITY AFFECTING THE CANOSSA GEOSITE (NORTHERN APENNINES, ITALY)

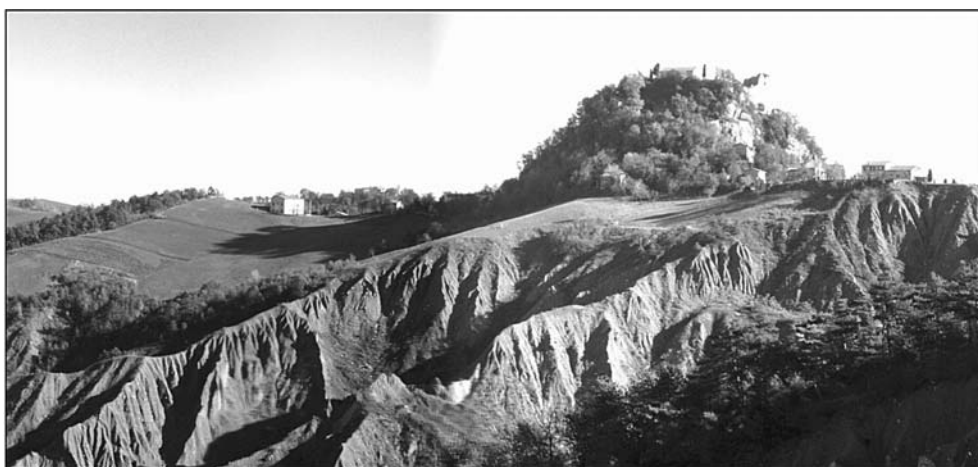
FIG. 2 - General view of the Canossa calcarenite cliff, with the ruins of the castle, overlying gully morphology developed in polymictic breccias.

coordinates of the topographic benchmark placed on top of the hill are: 44°34'42 N lat. and 10°27'24 E long. from Greenwich. This small ridge rises some 50 m over the surrounding hills and its highest point is 578 m a.s.l., whereas the approximate volume of the entire arenaceous cliff is 500,000 m³ (fig. 2).

The boundary between the Pantano Formation and the underlying polymictic breccias is found at the altitude of 525 m a.s.l., and creates a quite contrasting landscape between the steep cliff slopes, the gently sloping cultivated fields to the east and the rugged badlands to the west (figs. 2 and 4).

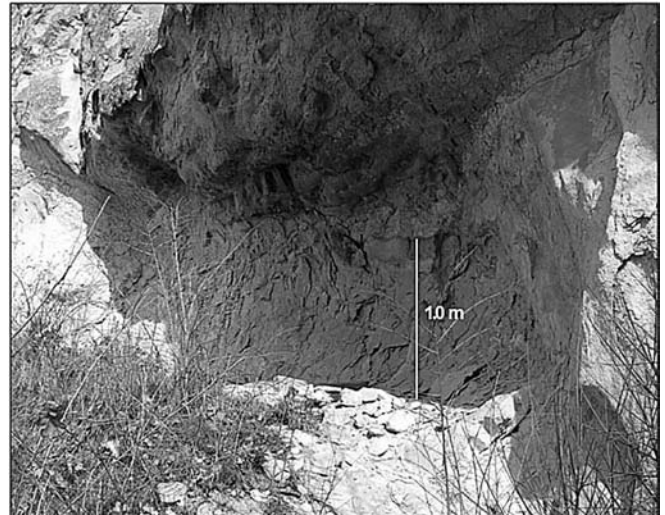
FIG. 3 - Niche due to differential erosion on the NW slope.

The entire calcarenite slab is affected by various sub-vertical discontinuity systems, with prevailing Apennine and anti-Apennine directions, corresponding to the two main structural lineations of this mountain chain (Gelmini, 1990), which subdivide the slab into several large rock strips. The presence of layers showing different levels of competence leads to the formation of ledges and indentations. Numerous niches, corresponding to eroded epigenetic concretions are also typical of the rock slopes (fig. 3).

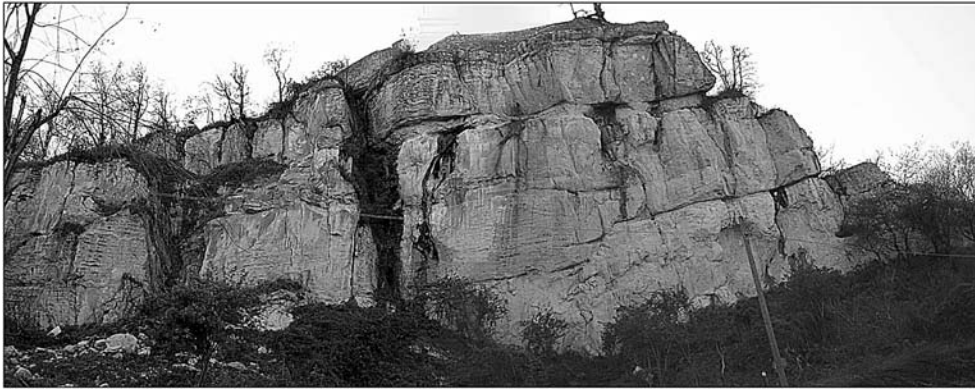
FIG. 5 - Present situation of the NE side of Canossa cliff undergoing block spreading (April 2007).

The most active processes are found on the NE slope, where dense jointing and dip-downstream layers (dip 25° to 35°) favour the onset of rock falls and block spreads (fig. 5). Other movements are located on the S-SW slope, where tensile stresses have caused the opening of several rock discontinuities. These joints are subject to progressive widening with time, as witnessed by surveys carried out in the past (De Beer, 1979; Soprintendenza Beni Ambientali-Architettonici, 1988), which leads eventually to rock block detachment and fall, with risk not only for the preservation of the geosite itself but also for transport infrastructures and residential buildings.

The clayey slopes surrounding the cliff are subject to creep and in some areas small, superficial, rotational slides occasionally take place following intense precipitation. Furthermore, the seasonal plasticisation of these soils has greatly contributed to the disarray conditions affecting the Canossa cliff. This type of mass movement leading to progressive dismembering of the rock strips making up the Canossa cliff may be ascribed to block spreading (Cruden & Varnes, 1996).

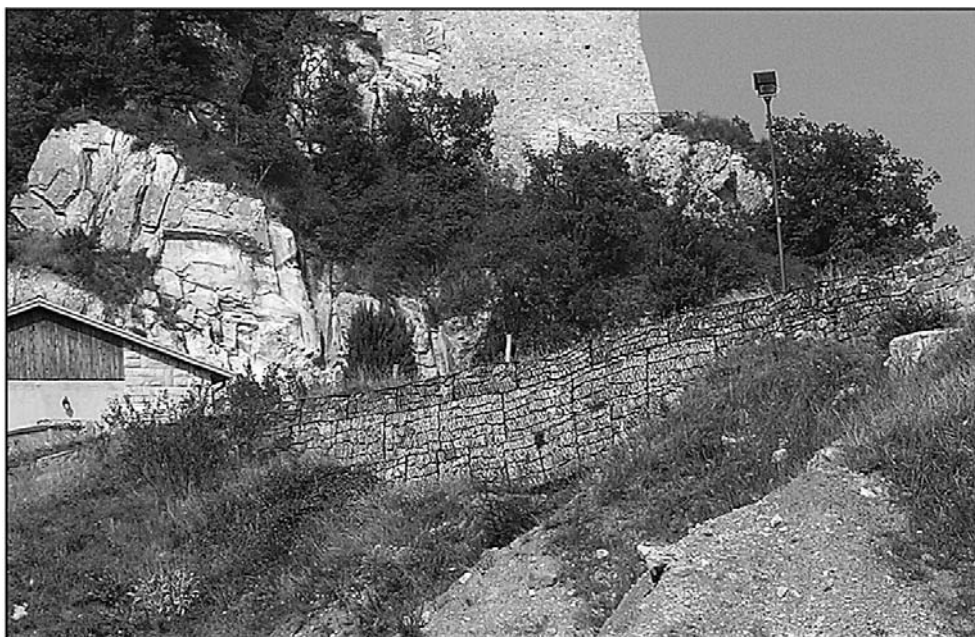
FIG. 6 - The gabion wall affected by gully erosion.

Retrogressive gully erosion is most visible at the foot of the gabion wall supporting the car park adjacent to a snack-bar in Canossa (fig. 6).

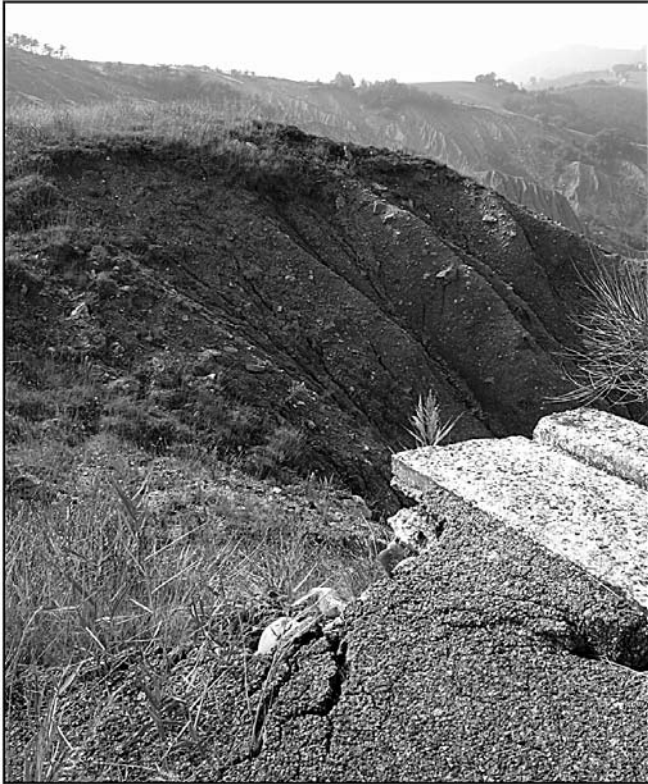
FIG. 7 - Remains of the old provincial road destroyed by gully erosion.

Other evidence of active gully erosion is provided by the remnants of the old provincial road, now almost completely obliterated (fig. 7).

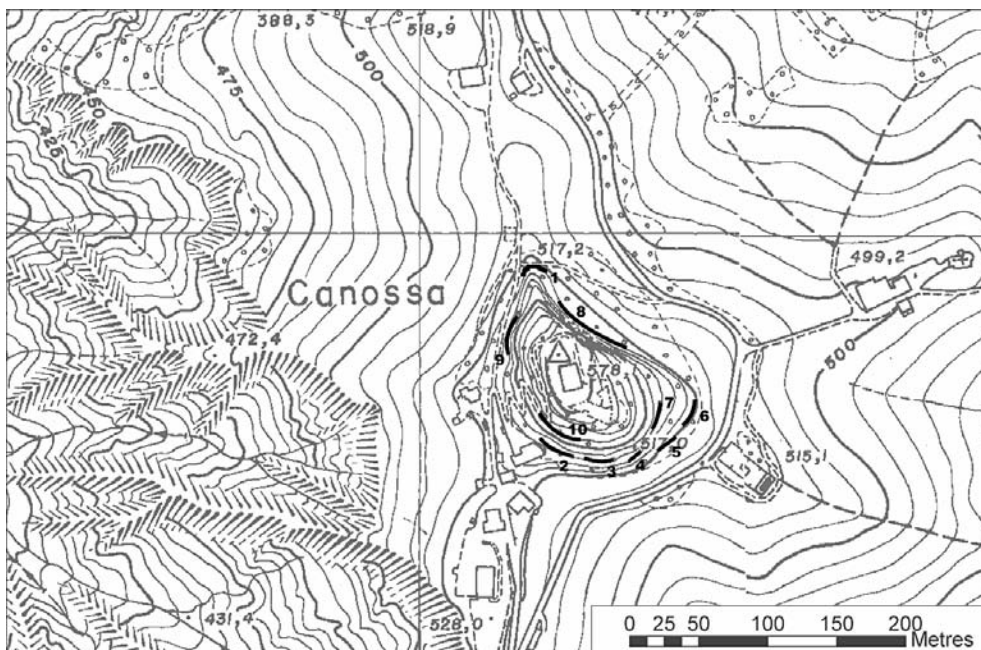
FIG. 8 - The Canossa cliff showing the location of the ten structural regions identified (drawn on CTR 1:5000 topographic maps nos. 218021-024, Regione Emilia-Romagna).

In applying this classification system, the rock mass is divided into a number of structural regions and each region is classified separately. The boundaries of the structural regions usually coincide with a major structural feature such as a fault or with a change in rock type. In some cases, significant changes in discontinuity spacing or characteristics, within the same rock type, may necessitate the division of the rock mass into a number of small structural regions, as in the case here discussed where ten structural regions were defined (fig. 8).
