PERIGLACIAL CASCADING PROCESS IN AN ALPINE ENVIRONMENT: AN EXAMPLE OF AN ICE AVALANCHE-INDUCED DEBRIS FLOW IN FERRET VALLEY (COURMAYEUR, ITALY)

On 23 June, 2022, a debris flow occurred in the Montitaz Stream (Mont Blanc area), which flows off the Planpincieux Glacier snout. It destroyed the bridge that links the hamlets of Planpincieux and Rochefort. Using a multi-source dataset from UAV, satellite and terrestrial sensors belonging to the Planpincieux Glacier monitoring network, we reconstructed the series of events that led to the debris flow. We found evidence that this resulted from a cascading process which started with an ice avalanche of 4200 m³ falling over a reformed glacieret that lies 500 m downstream from the glacier front. Subsequently, the deposited ice avalanche formed an unstable ice dam along the Montitaz Stream riverbed, causing a mixed accumulation of water and ice debris. Finally, the dam collapsed, originating a debris flow consisting of ice, water and

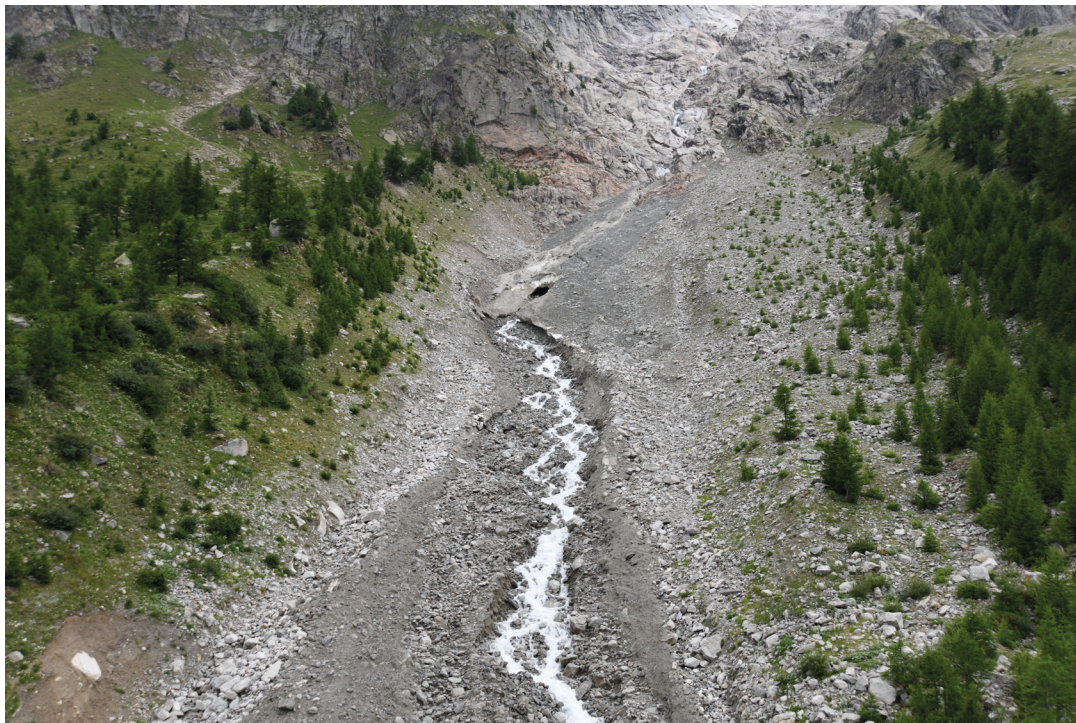
FIG. 2 - View of the ice avalanche detached from the Planpincieux Glacier front and accumulated in the Montitaz Stream, between 1900 m and 2000 m a.s.l., at the base of the rocky slope downvalley the Planpincieux Glacier front. Note that the stream disappears and flows under the Montitaz Glacieret and re-emerges at the lower end of the glacieret. The photo was acquired in the morning after the debris flow event. Note the marks of flooding outside the stream (dark gray).

A lower glacial body – hereafter called Montitaz Glacieret – fed by the accumulation of ice avalanche deposits from the upper front of the Montitaz Lobe disappeared in 2015 and reformed in 2019 due to the increased ice fall activity. The glacieret lies at 2000-2100 m at the top of the glacial fan (i.e., at the beginning of the second sector formerly described of the Montitaz Stream). Its extension can vary in one single season, mainly during the melt season, as well as between different years as a balance of ice fall activity and the ablation during the warm season (fig. 2).

the glacieret (reference fig. 2 and fig. 3). In correspondence with the Montitaz Glacieret, the NDWI shows a sharp decrease, thereby marking that water flowed underneath the ice deposit. The NDWI value is relatively small, but the relevance of the data consists more on the NDWI gradient along the profiles and the spatial coherence in the gradients along the transect. It should also be considered that such a small stream cannot build up a strong signal with the ground resolution of the available sensors (10 m and 3 m).

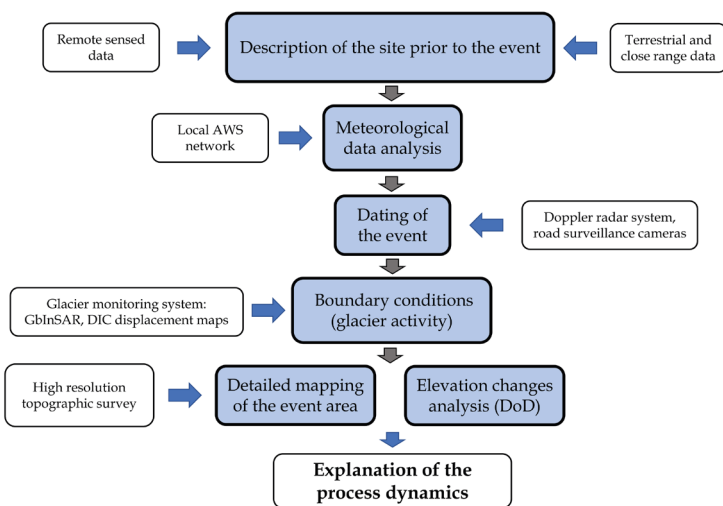
FIG. 3 - Workflow summarizing the methodology applied in this study for the reconstruction of the dynamics that caused the Montitaz Stream debris flow on 23 June, 2022.

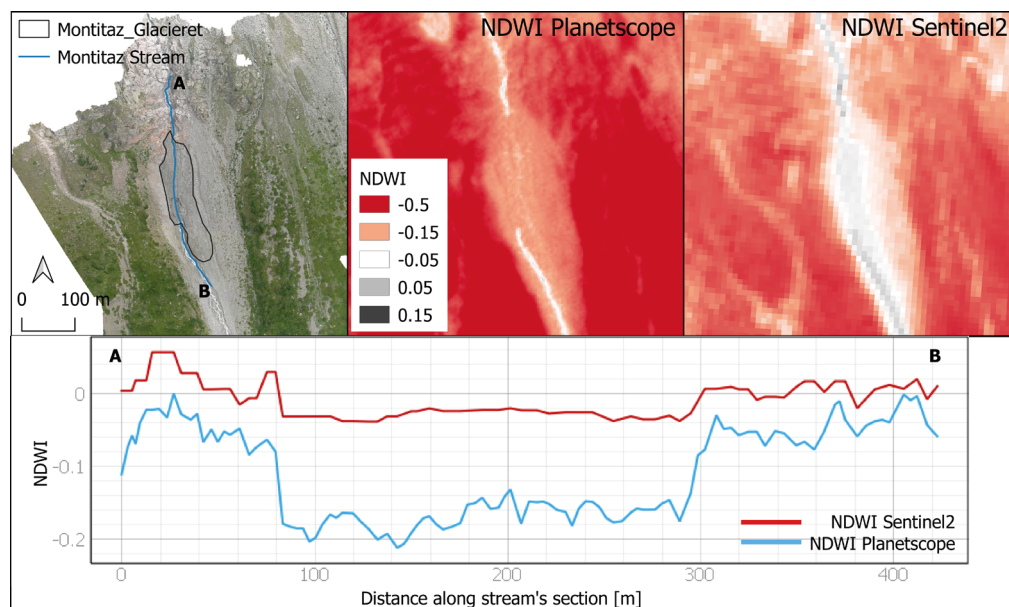
FIG. 4 - NDWI index maps obtained from Sentinel-2 and PlanetScope imagery taken on the 23 June, 2022 (h 12:38 and h 12:00 local time, respectively). Water flowing into the Montitaz Stream is highlighted by higher NDWI values along the thalweg, while lower values characterise the area of the Montitaz Glacieret where the water disappears, flowing underneath the glacieret. ©Planet Labs PBC, CC BY-NC-SA 2.0.

Fig. 4 shows the NDWI on 23 June, 2022 at h 10:30, which is higher along the thalweg of the Montitaz Stream above 2100 m, thus indicating a high probability of the presence of water, and below 2000 m, where the stream runs off

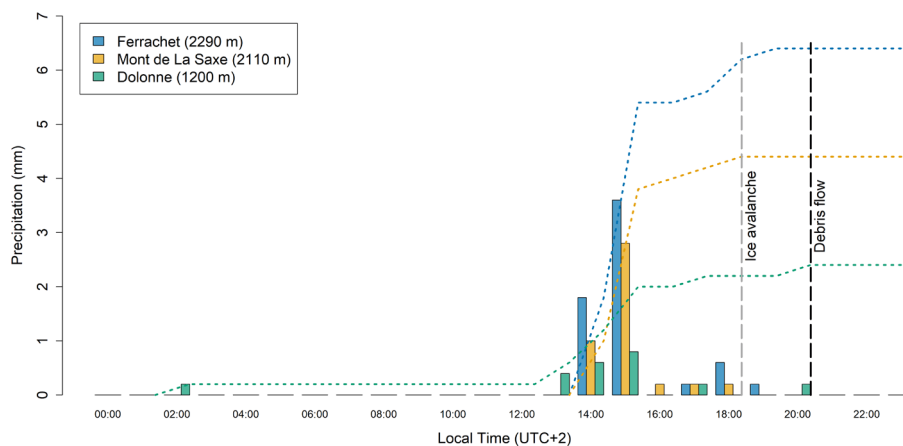
FIG. 5 - Pluviometric data from the Ferrachet, Dolonne and La Saxe AWS located in the Ferret Valley. Histogram refers to hourly precipitation, dashed blue yellow and green lines indicate cumulated precipitation of the single AWS. Vertical dashed grey and black lines indicate the timing of the ice avalanche and debris flow events.

Fig. 4 shows hourly precipitation data collected by the Ferrachet, Dolonne and La Saxe AWSs. The maximum total precipitation registered in the 24 hours before the debris flow was 6.5 mm, and approximately 90% of the cumulated precipitation fell between h 14:00 and h 15:00. Moreover, no rainstorms were registered in the study area on the day of the event (fig. 5).

The first case is highly improbable because the cumulated precipitation and intensity were very limited and concentrated several hours before the debris flow, as shown in fig 5. The distribution of precipitations excluded a direct impact in the debris flow trigger.

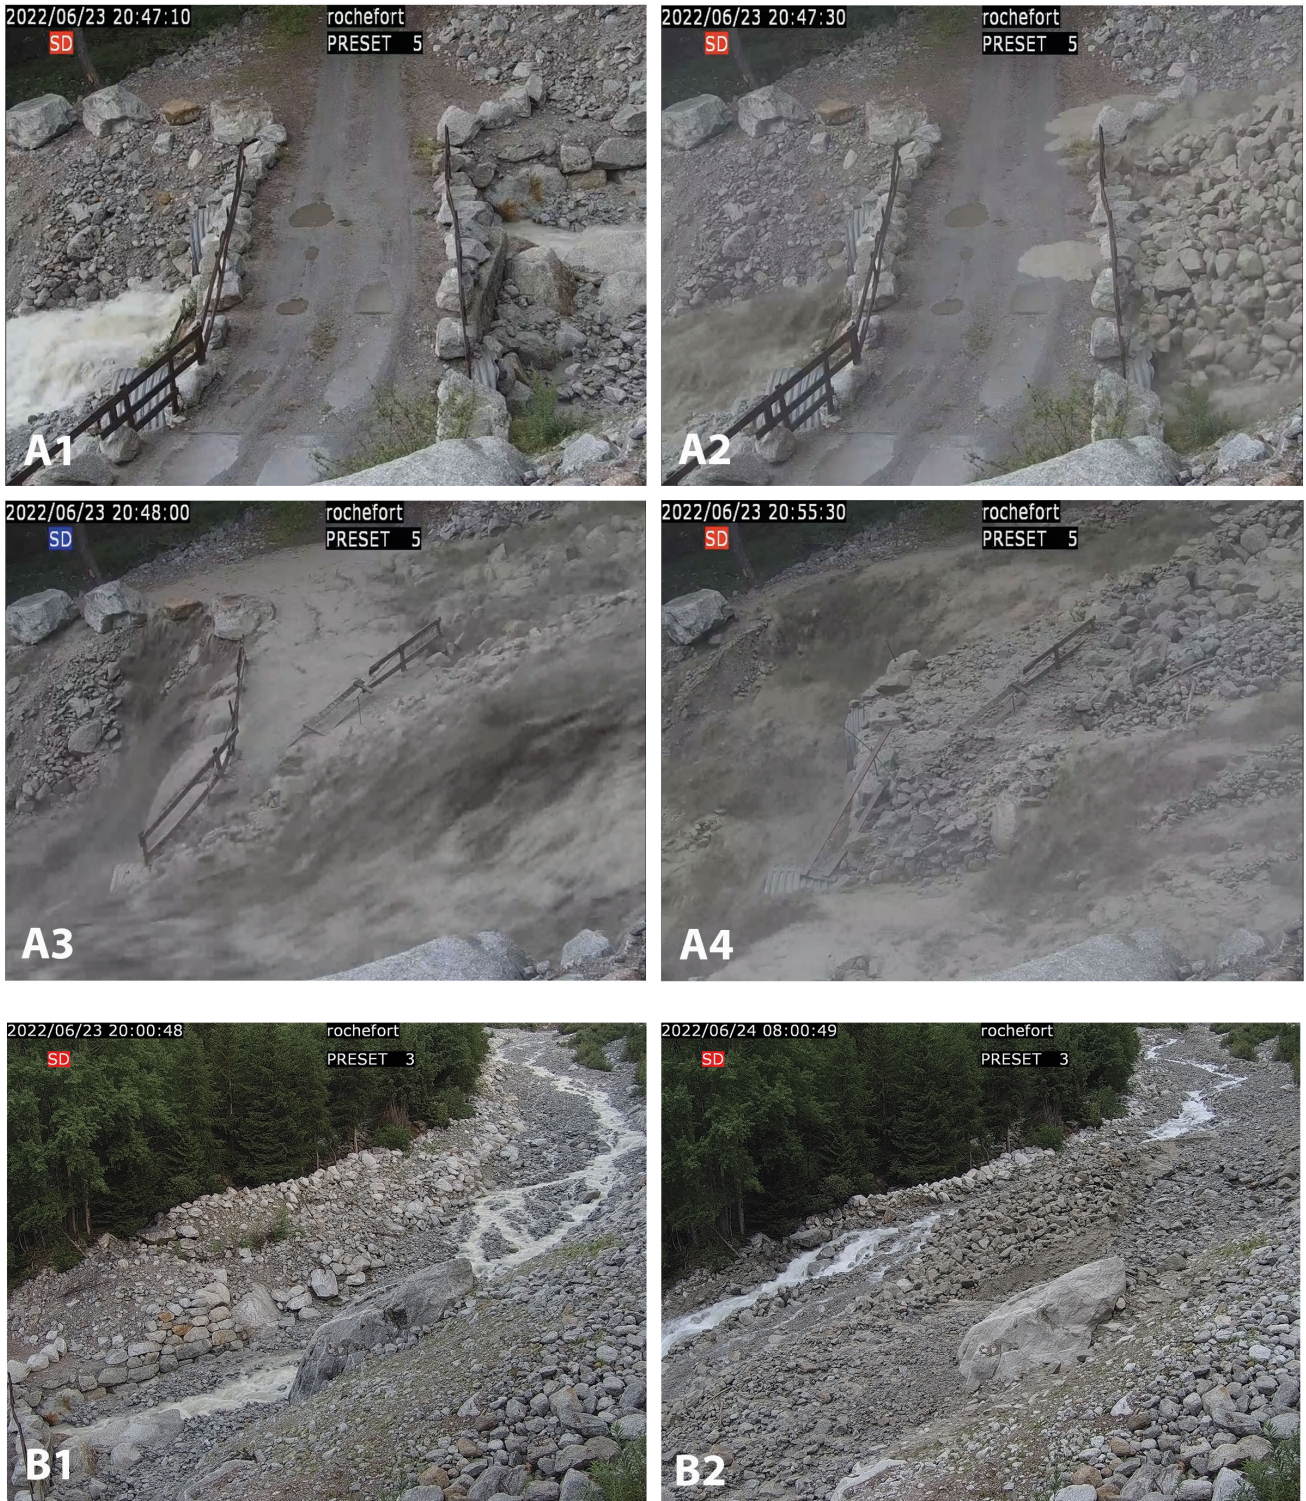
FIG. 6 - Sequence of images of the Rochefort bridge that crosses the Montitaz Stream. A1 to A4 are images of the camera surveying the bridge when the debris flow impacted the bridge h 20:47-h 20:55. B1 and B2 are images of the camera surveying the Montitaz Stream just above the bridge at h 20:00 before and at h 08:00 the morning after the event. A significant deposition of debris is evident.

We determined the precise debris flow timing from the video of the survey webcam installed close to the bridge of the Montitaz Stream. The impact of the debris flow on the bridge occurred at h 20:45 (fig. 6A2). During the event, the bridge was severely damaged (fig. 6A3-4).

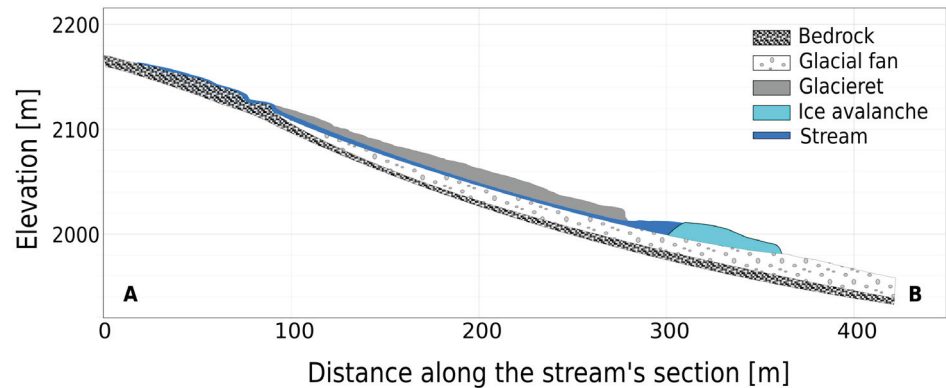
FIG. 11 - Conceptual model of the event triggering mechanism. The thickness of the glacieret and the ice avalanche are magnified for better reading.

Therefore, the probable dynamics of the cascading process is the following: the ice avalanche deposit formed an unstable ice dam just downstream from the glacieret. The input provided by the Montitaz Stream caused water accumulation above the dam for approximately one to two hours. Subsequently, the dam collapsed. Then, water, ice debris and morainic material were released abruptly, triggering a debris flow. Flowing downstream, the debris flow entrained more debris from the glacial fan and reached the Planpincieux-Rochefort road, damaging the bridge and filling the riverbed with up to 6 m of debris deposit (fig. 11).
